**CITY OF WESTBROOK-PUBLIC SAFETY COMMITTEE  
AGENDA  
MONDAY DECEMBER 11, 2017  
6:30PM  
WESTBROOK HIGH SCHOOL ROOM 114**

# **Engine 4 Apparatus Review**

November 20, 2017  
Jerre Bryant, City Administrator  
City of Westbrook  
2 York Street  
Westbrook, ME 04092

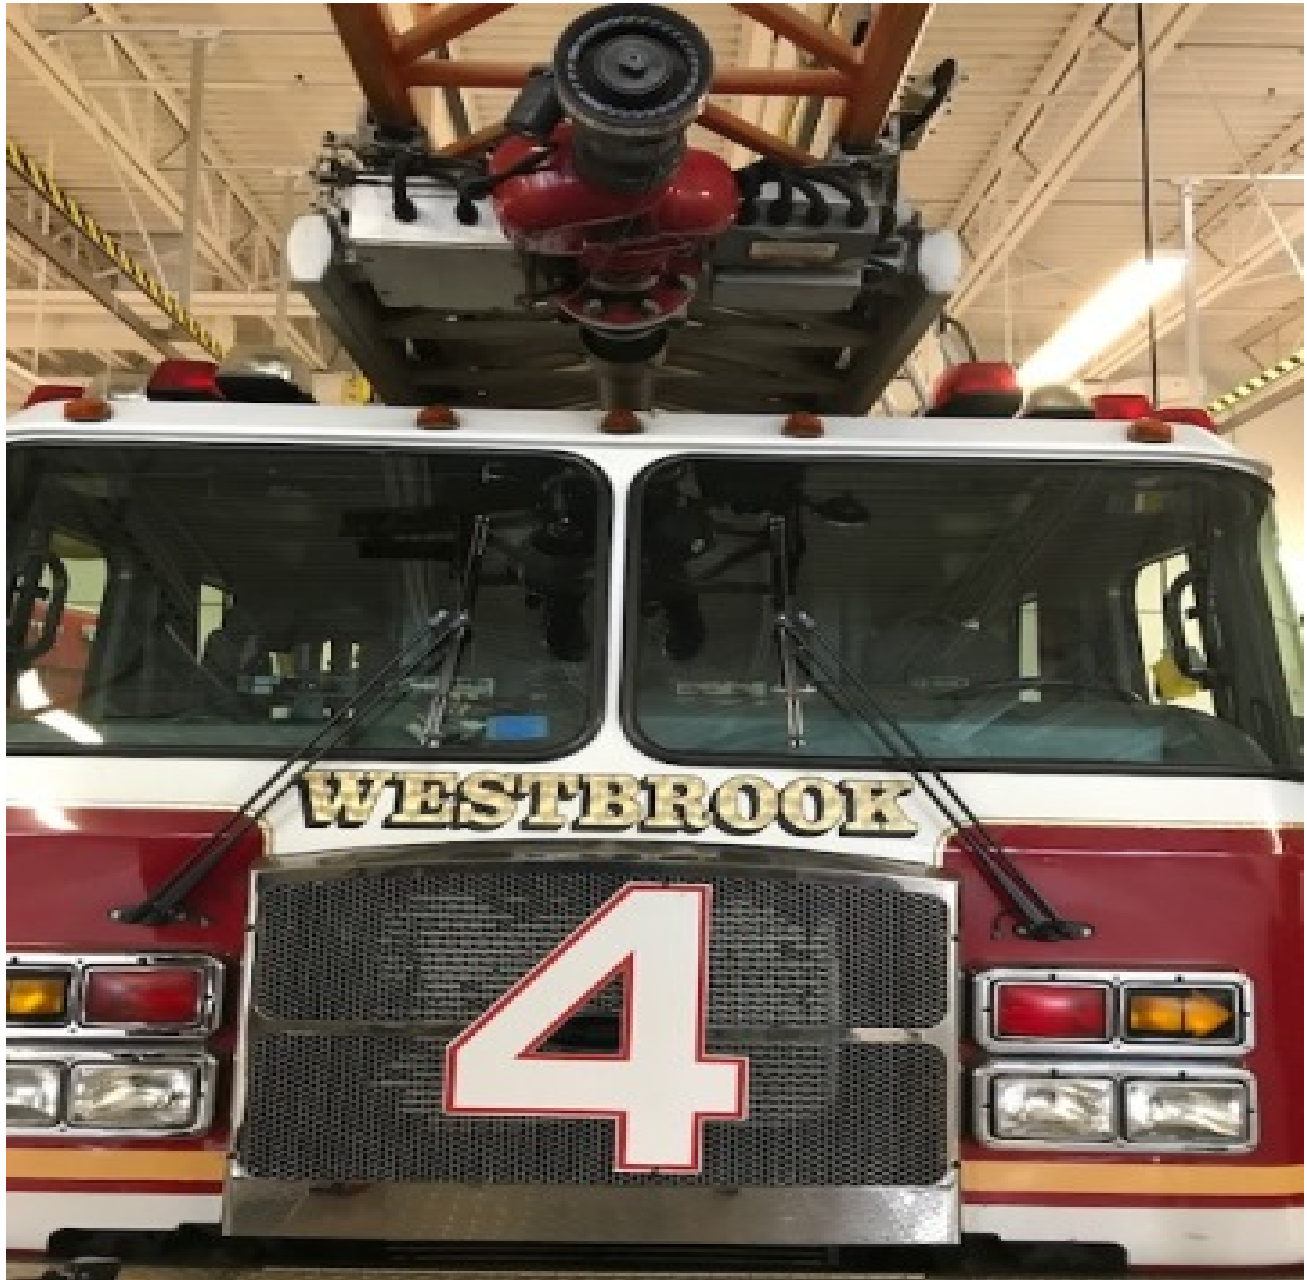
**Figure 1**

*2004 E-One HP 75 Quint  
Manufactured August 2004  
Registration Number: 403-562*

*Mileage: 89,733  
Engine Hours: 9,643.4*

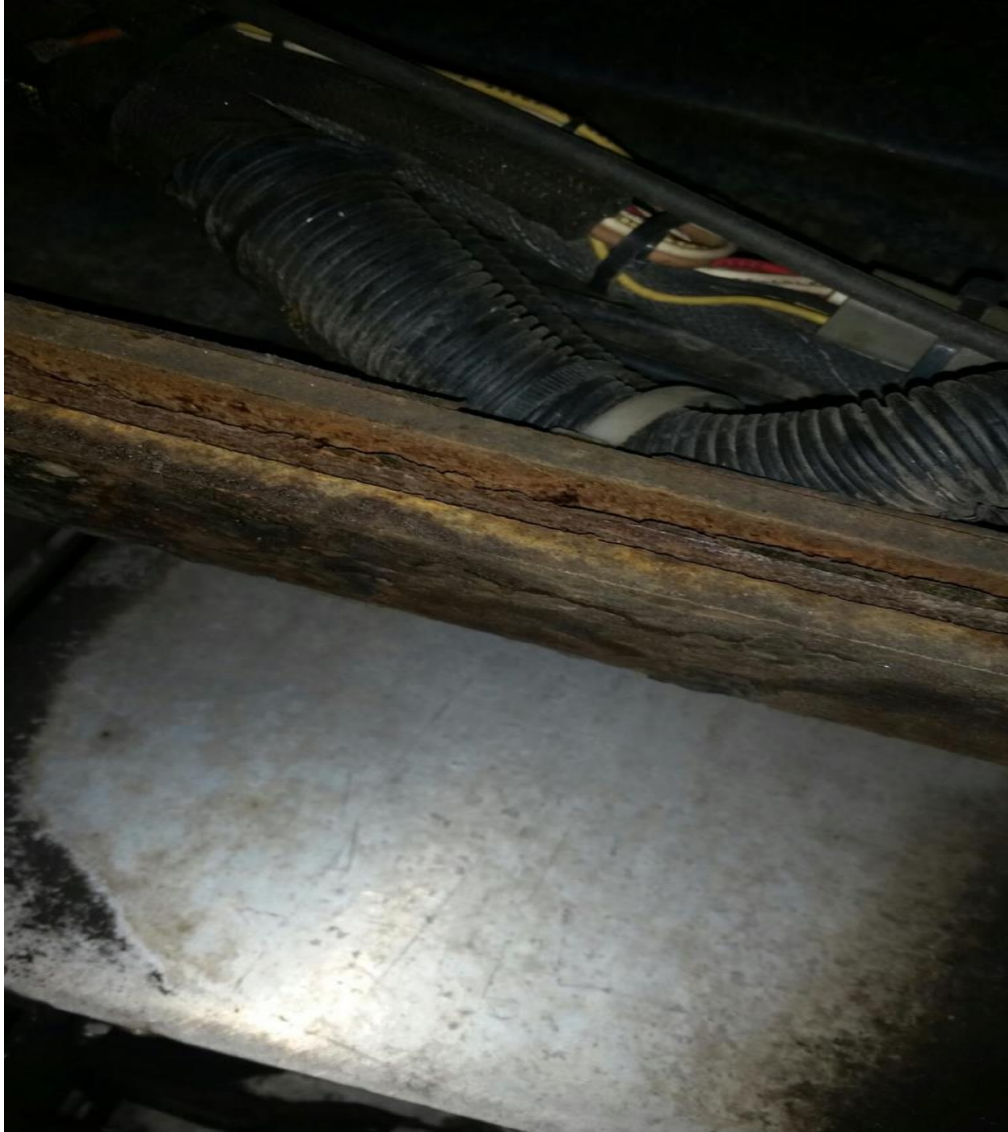
**Figures 2, 3, 4, 5, & 6 show various locations and degrees of rust and corrosion on the apparatus chassis.**

Each of these photos shows to some degree of rust, sand, dirt, and salt deposits on different surfaces of the undercarriage or frame rails. This is exactly what we need to get rinsed off the apparatus on an ongoing and regular basis. Road dirt holds moisture, contains road salts and other corrosive chemicals that promote rust and rot. The new Public Service Building has a

All of this brings us back to Engine 4 and their corrosion problems. It is entirely possible that the corrosion issues are being exacerbated by electrical issues and electrolysis further compounded by grounding problems. It is recommended that any of our fire apparatus that are not fully grounded, including Engine 4, be retrofitted with ground straps.
